CASE HISTORY

Legion Lighting

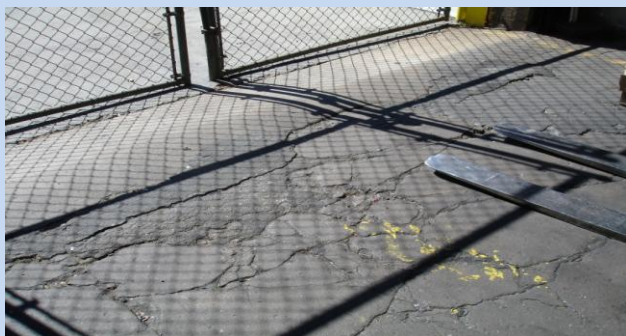
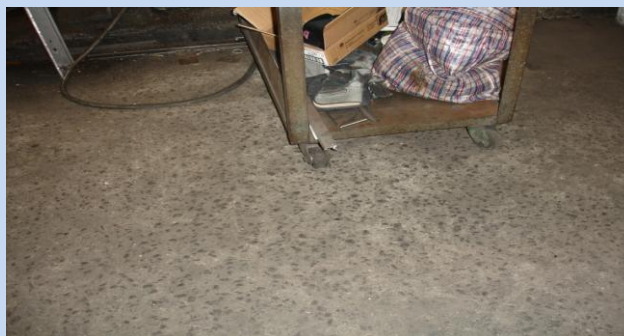
The Challenge: The badly deteriorated condition of the concrete directly resulted in the delay of raw materials being supplied to the appropriate parts of the facility. The laborious and time consuming method of transporting the heavy pallet loads of raw materials around the plant were inhibiting production. As a result, fork trucks were operating under desired capacity, hand carts virtually impossible to move manually without substantial assistance and area maintenance was extraordinarily difficult.

The Solution: ESPOSITO LLC was chosen to correct the badly damaged concrete. ESPOSITO LLC removed all of the concrete in the two entry docks that had compressive concrete fractures and replaced it with 4000 PSI commercial grade concrete, re-enforced with anti-corrosive re-bar keyed into the existing concrete substrate. Using a closed system shot blast machine, ESPOSITO LLC then mechanically prepared the substrate.
