CASE HISTORY

Architectural Design

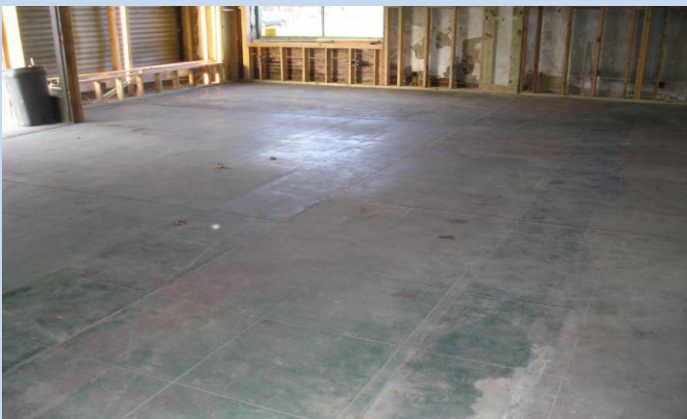
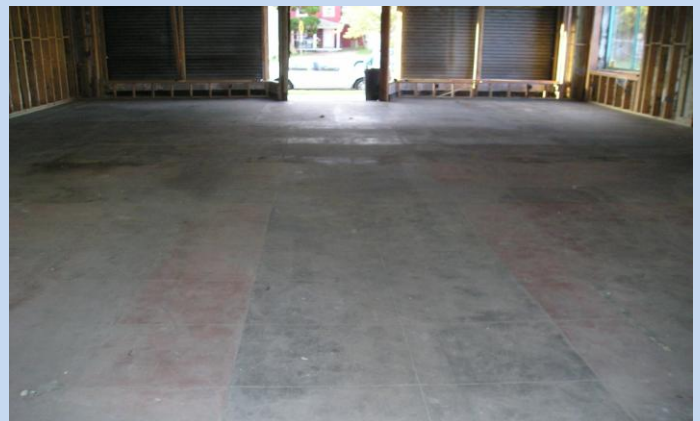
The Challenge: The customer purchased an older building to renovate and turn into their new millwork showroom. The building was used as an auto parts and machinist shop for the prior 90 years. The floor had been covered and coated with several layers of paint and left in a generally rough condition. The customer requested a natural, low maintenance, durable floor that would enhance and compliment the overall design concept.

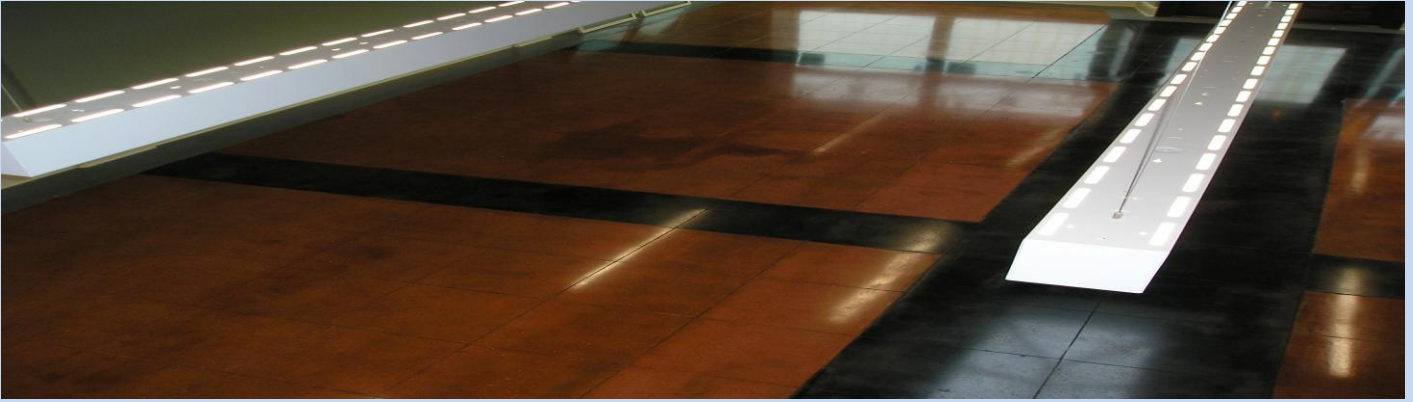
The finished product was clean, high sheen floor that was both naturally beautiful and functional. The customer was extraordinarily pleased with the outcome.
