CASE HISTORY

Clean Venture

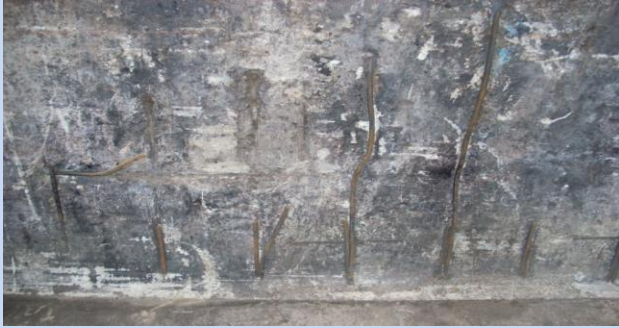
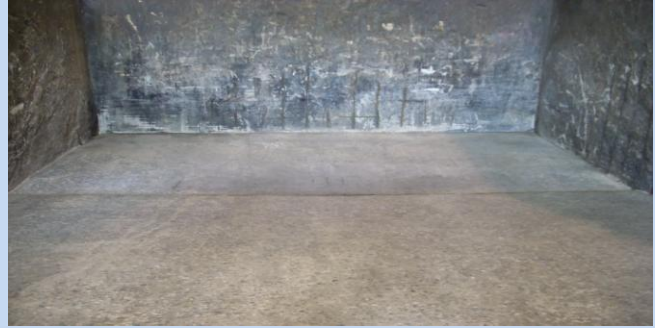
The Challenge: The concrete in this containment pit was deteriorating at an alarming rate, exposing rebar and aggregate. This resulted from the daily use and abuse of this area, as well as high levels of corrosive chemicals. ESPOSITO LLC was chosen to rectify this problem.
