CASE HISTORY

Franciscan Kitchen

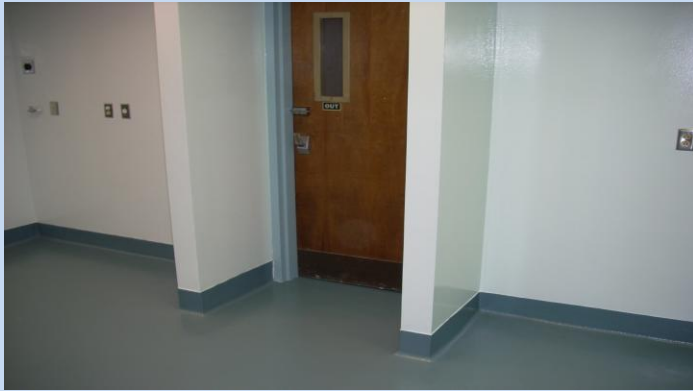
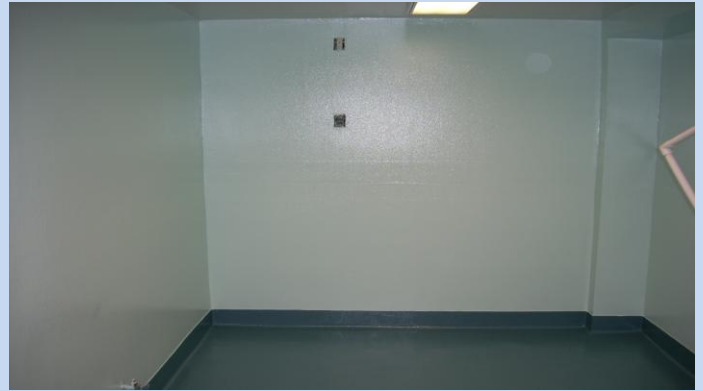
The Challenge: The existing tile floor was failing badly creating a very difficult surface to clean, maintain and keep sanitary. Along with the tile floor failing, the wall systems that were in place were old, porous, damaged and nearly impossible to clean. This client required a seamless floor and wall system that would be durable, sanitary, easily maintained and hold up to the rigorous demands of a working kitchen.
