CASE HISTORY

BMW Motors

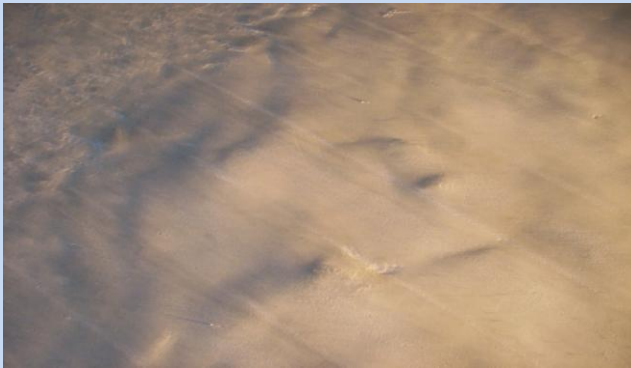
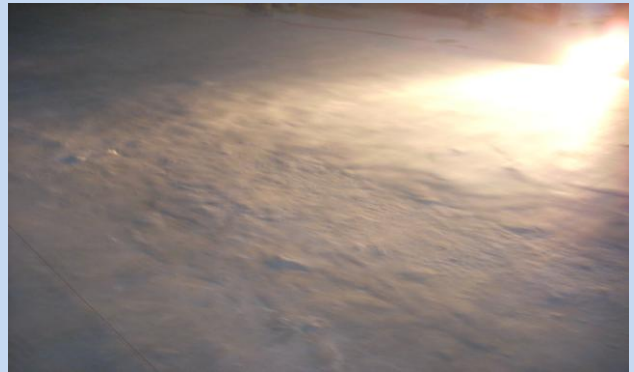
The Challenge: The finished surface of the concrete was un-acceptable. BMW was unable to put this service area into production. This client needed to re-surface the floor before opening the facility. The client required a floor that was extremely durable, aesthetically pleasing, and easily cleaned and maintained.

The Solution: Using a closed system shot blast machine, ESPOSITO LLC mechanically prepared the substrate by shot blasting the existing concrete to achieve the proper profile for maximum bond strength. ESPOSITO LLC installed a high density epoxy mortar floor system and abrasion resistant coating.
