CASE HISTORY

YMCA

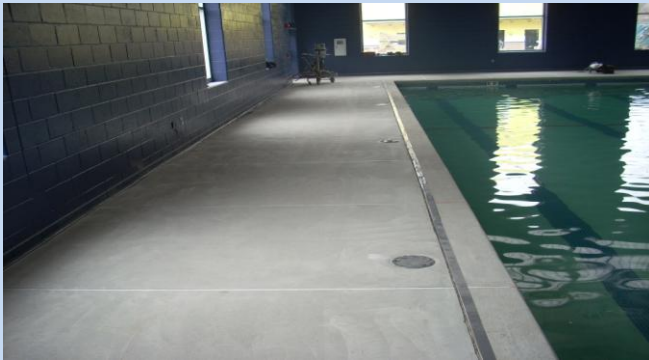
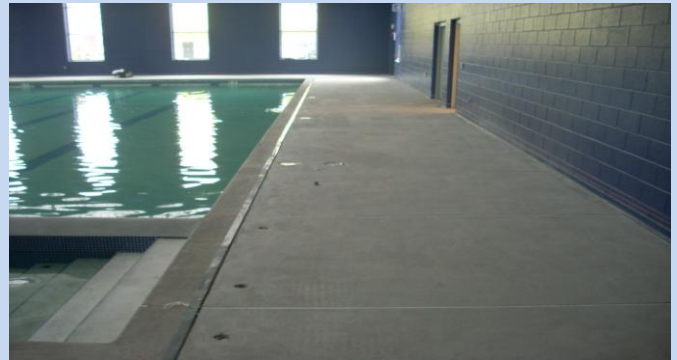
The Challenge: This YMCA was opening a brand new facility for the community. They required a floor system around the pool and in the locker room areas. The requirements were for a durable, slip-resistant, multi-colored decorative broadcast system that would require little maintenance and hold up in the moisture rich environment, as well as stand up to the cleaning chemicals associated with daily pool sanitary maintenance.

The Solution: ESPOSITO LLC was chosen to provide the YMCA with the right system. Working with YMCA, ESPOSITO LLC developed a Urethane based Decorative Broadcast system. This system would perform as desired and hold up in a demanding high moisture area that is regularly exposed to chemically cleaning agents and pool treatment products.

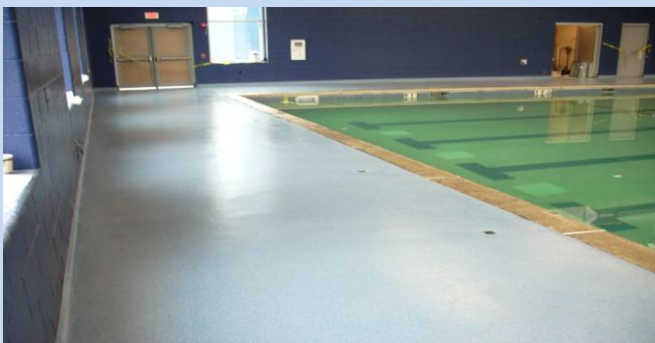
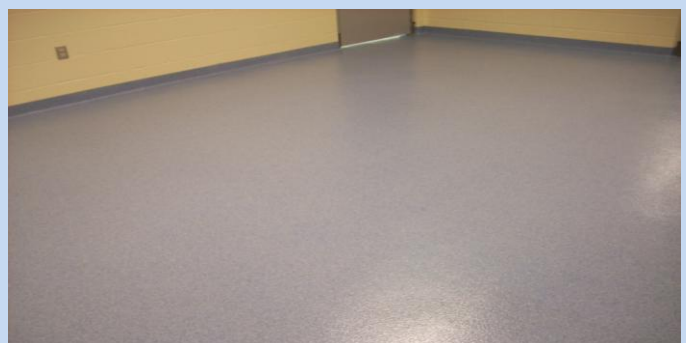
After the floor is shot blasted, the primer coat is applied. The desired multi-colored decorative broadcast sand is applied. A 4" sanitary cove base is installed up all vertical surfaces. A urethane undercoat is then applied with the second desired multi-colored quartz broadcast sand.

Finally a high-sheen, abrasion and chemical resistant urethane top coat is applied. The result was a durable, abrasion resistant floor system that provided a textured finish for slip resistance.
